R-90-08

HYDRAULIC MODEL STUDY OF THE THEODORE ROOSEVELT DAM SPILLWAY MODIFICATIONS

July 1990

U.S. DEPARTMENT OF THE INTERIOR
Bureau of Reclamation
Denver Office
Research and Laboratory Services Division
Hydraulics Branch

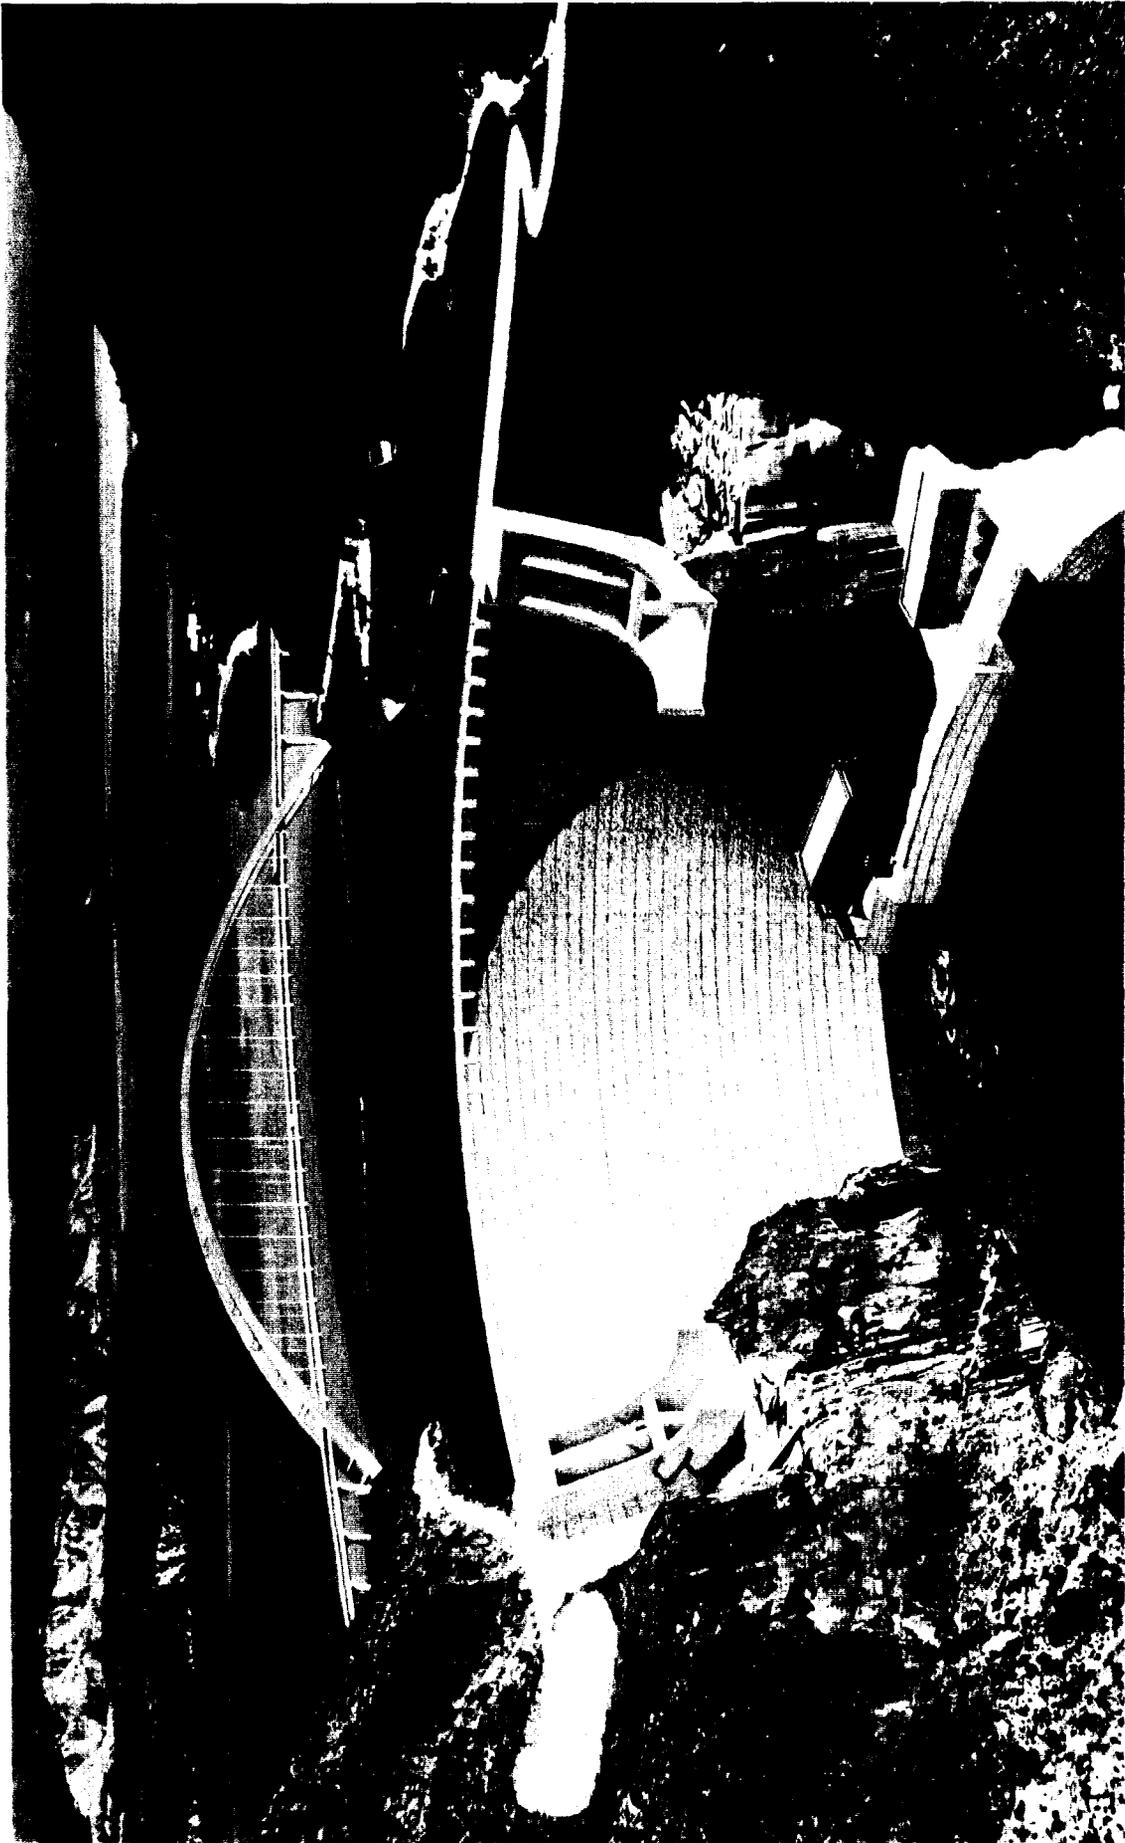
Figure 2. - Artist's conception of the proposed modifications for Theodore Roosevelt Dam - 1989.

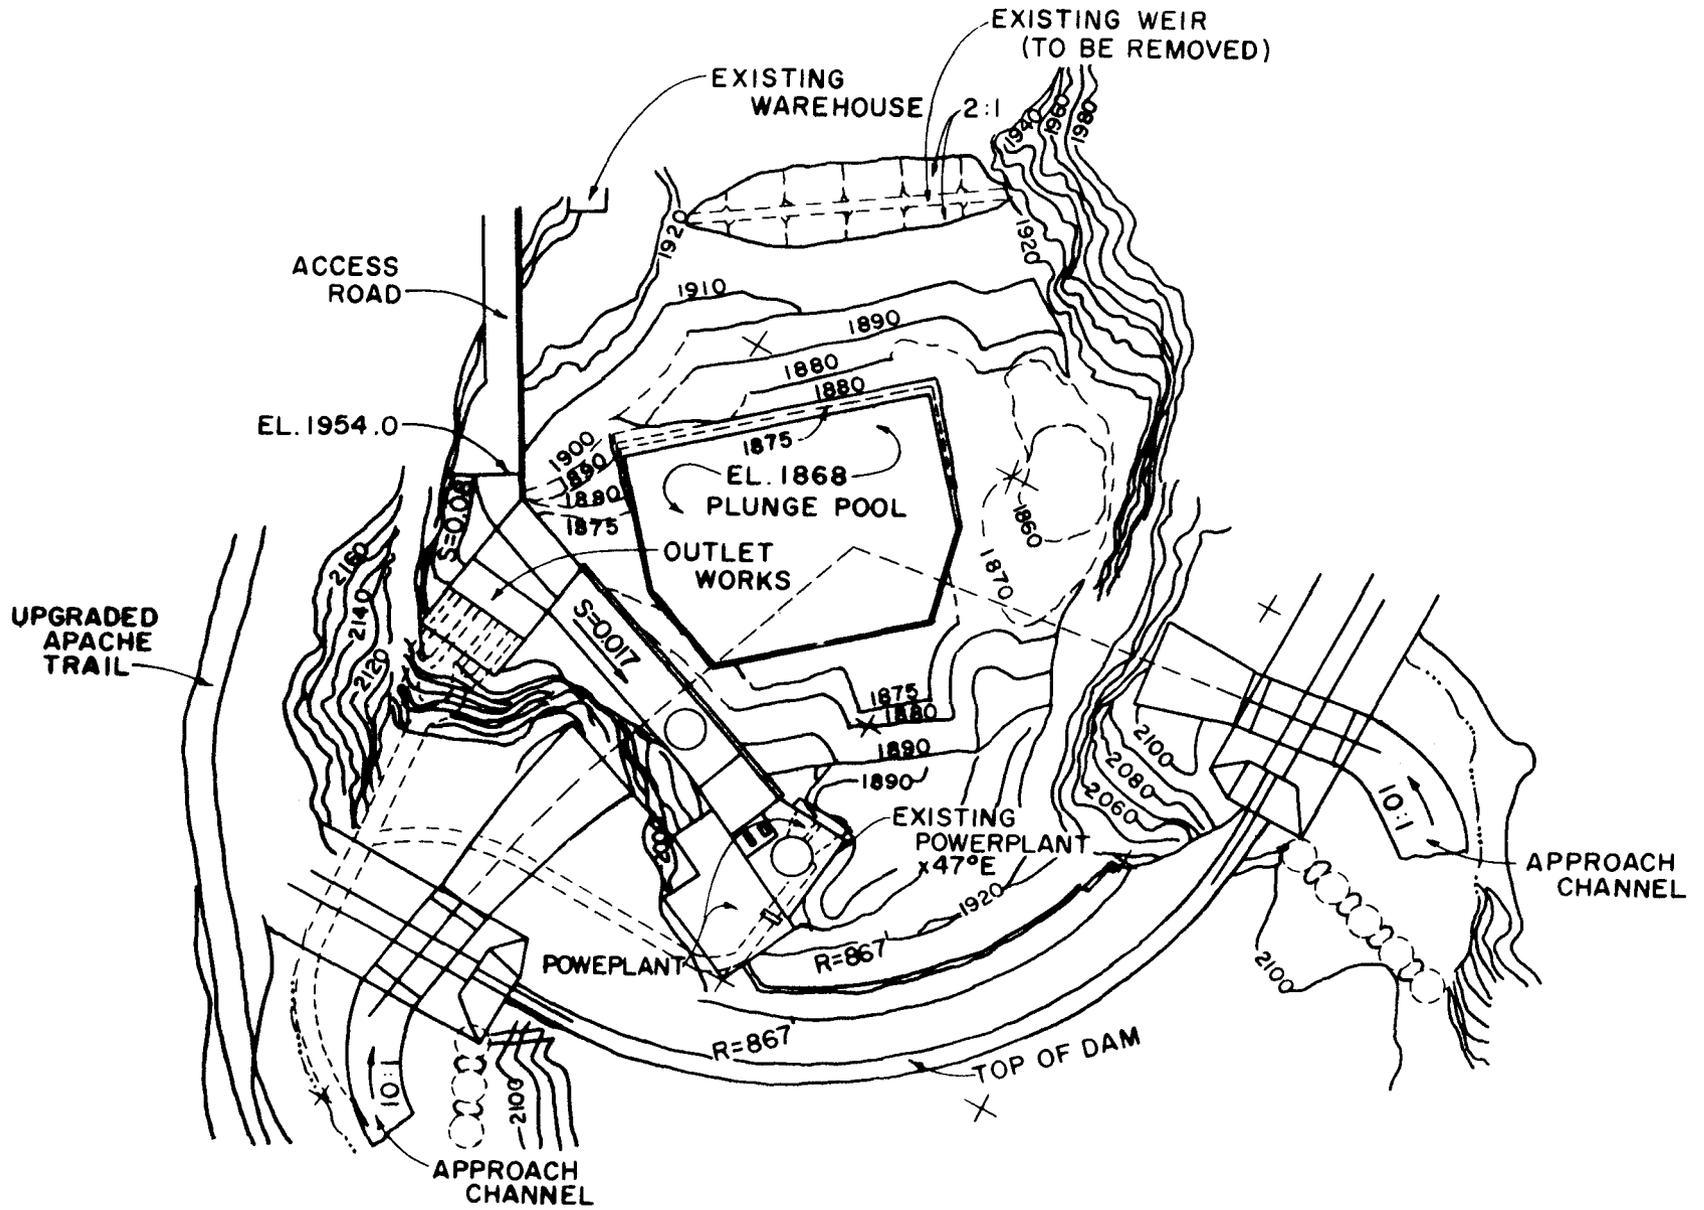
Figure 3. - Original design of the waterways for the double-curvature arch dam.

The location and shape of the initial plunge pool are shown on figure 3. The pool shape and location had been selected from a compromise between a smaller shape centered on the impingement point determined adequate by the designers and a shape covering a much larger area deemed necessary by a consultant review board. Operation of the model under the original design discharge of 54,380 ft³/s showed that no major modifications would be necessary (fig. 17); however, operation under the revised design discharge of 135,000 ft³/s indicated all components of the plunge pool needed reevaluation (fig. 27). The pool was located too far to the left of the jet impingement area, was too shallow, was improperly shaped, and did not direct the flow toward the river channel.

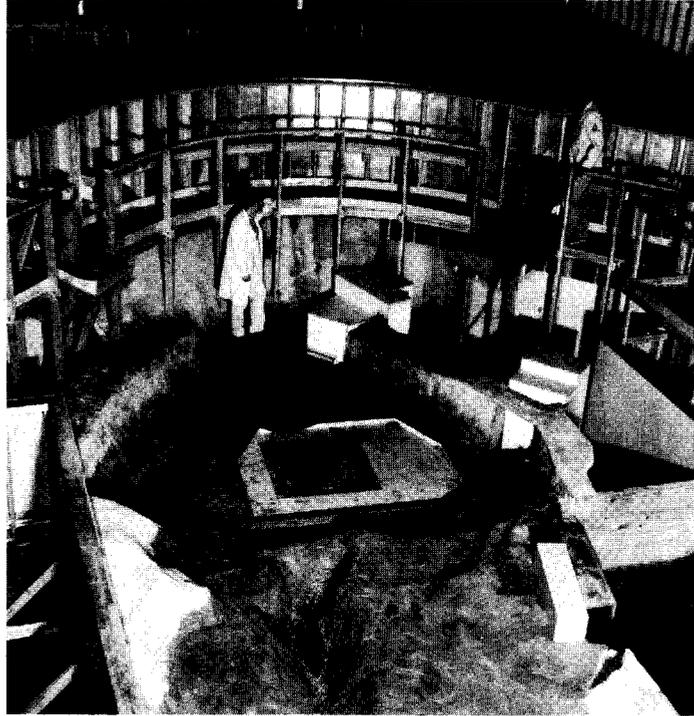
Figure 4. - Overall view of the 1:40 scale model with the original waterway designs of the double-curvature arch dam.

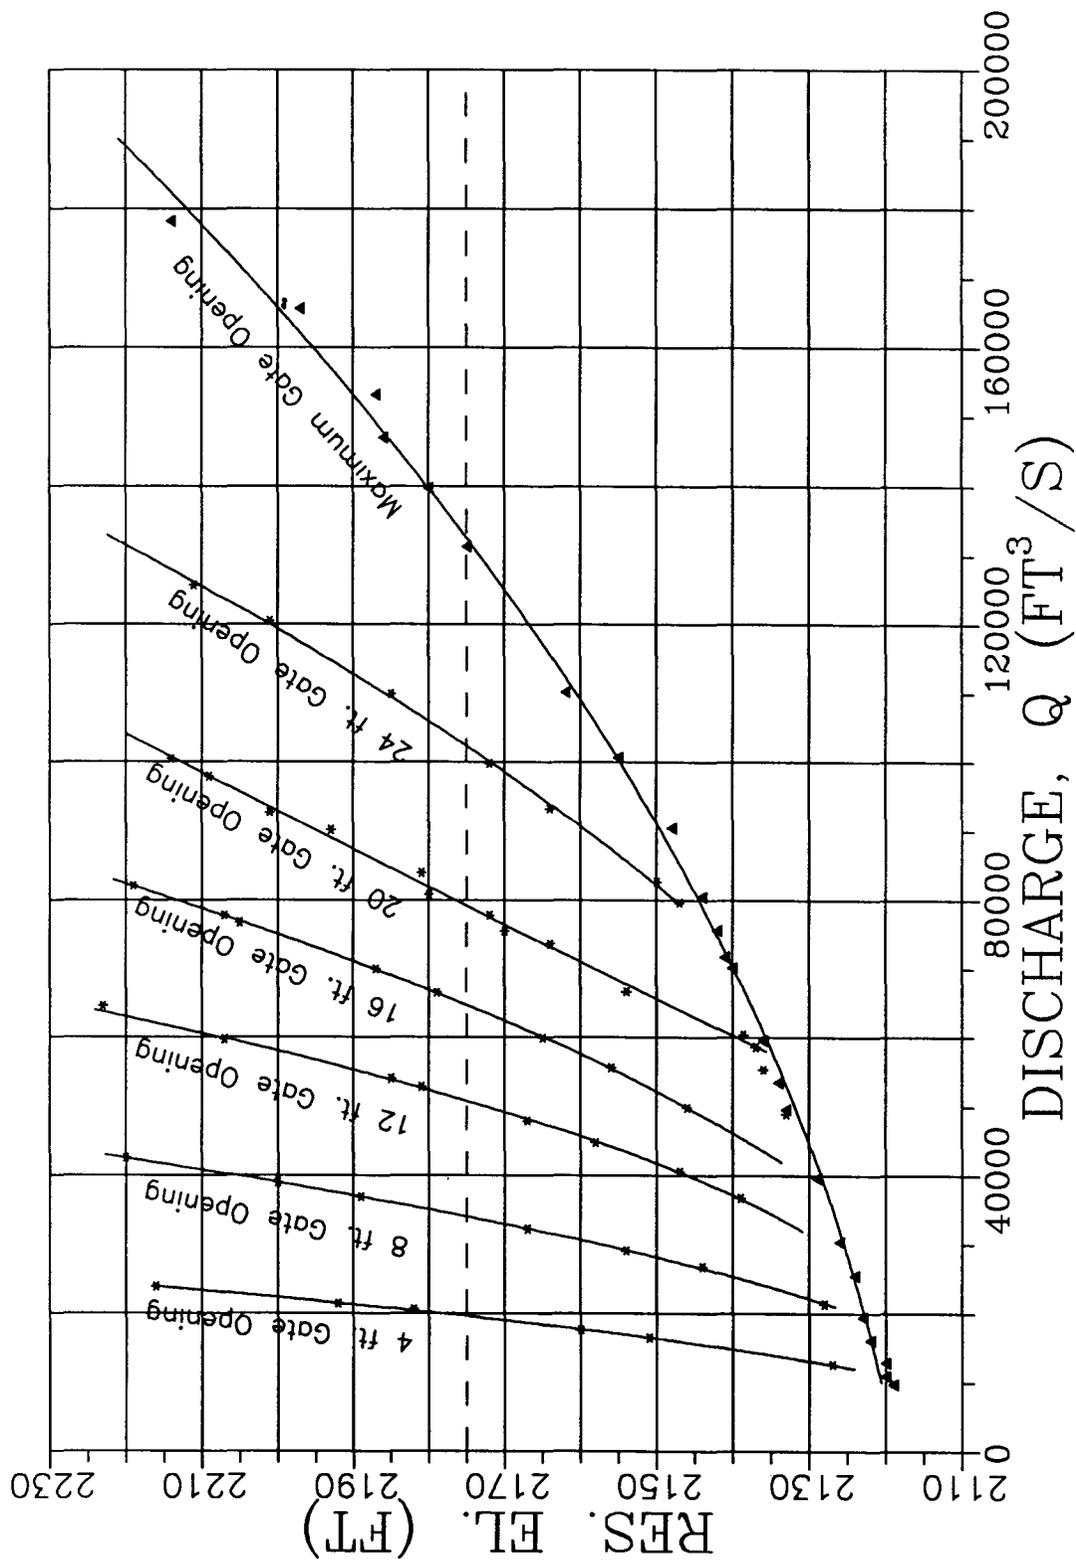
Figure 6. - Discharge rating curve for simultaneous operation of both spillways.

Spillway discharge curves were recompiled due to the change in centerline locations and the steeper slope of the left spillway. The gate seat elevations for the right and left spillways are 2086.60 and 2088.73 feet, respectively. The discharge curves were developed for 4-foot gate opening intervals, measured normal to the spillway slopes. Discharge curves were developed for each spillway for both simultaneous and separate operating conditions (figs. 6, 7, and 8). The required discharge capacity was still maintained.

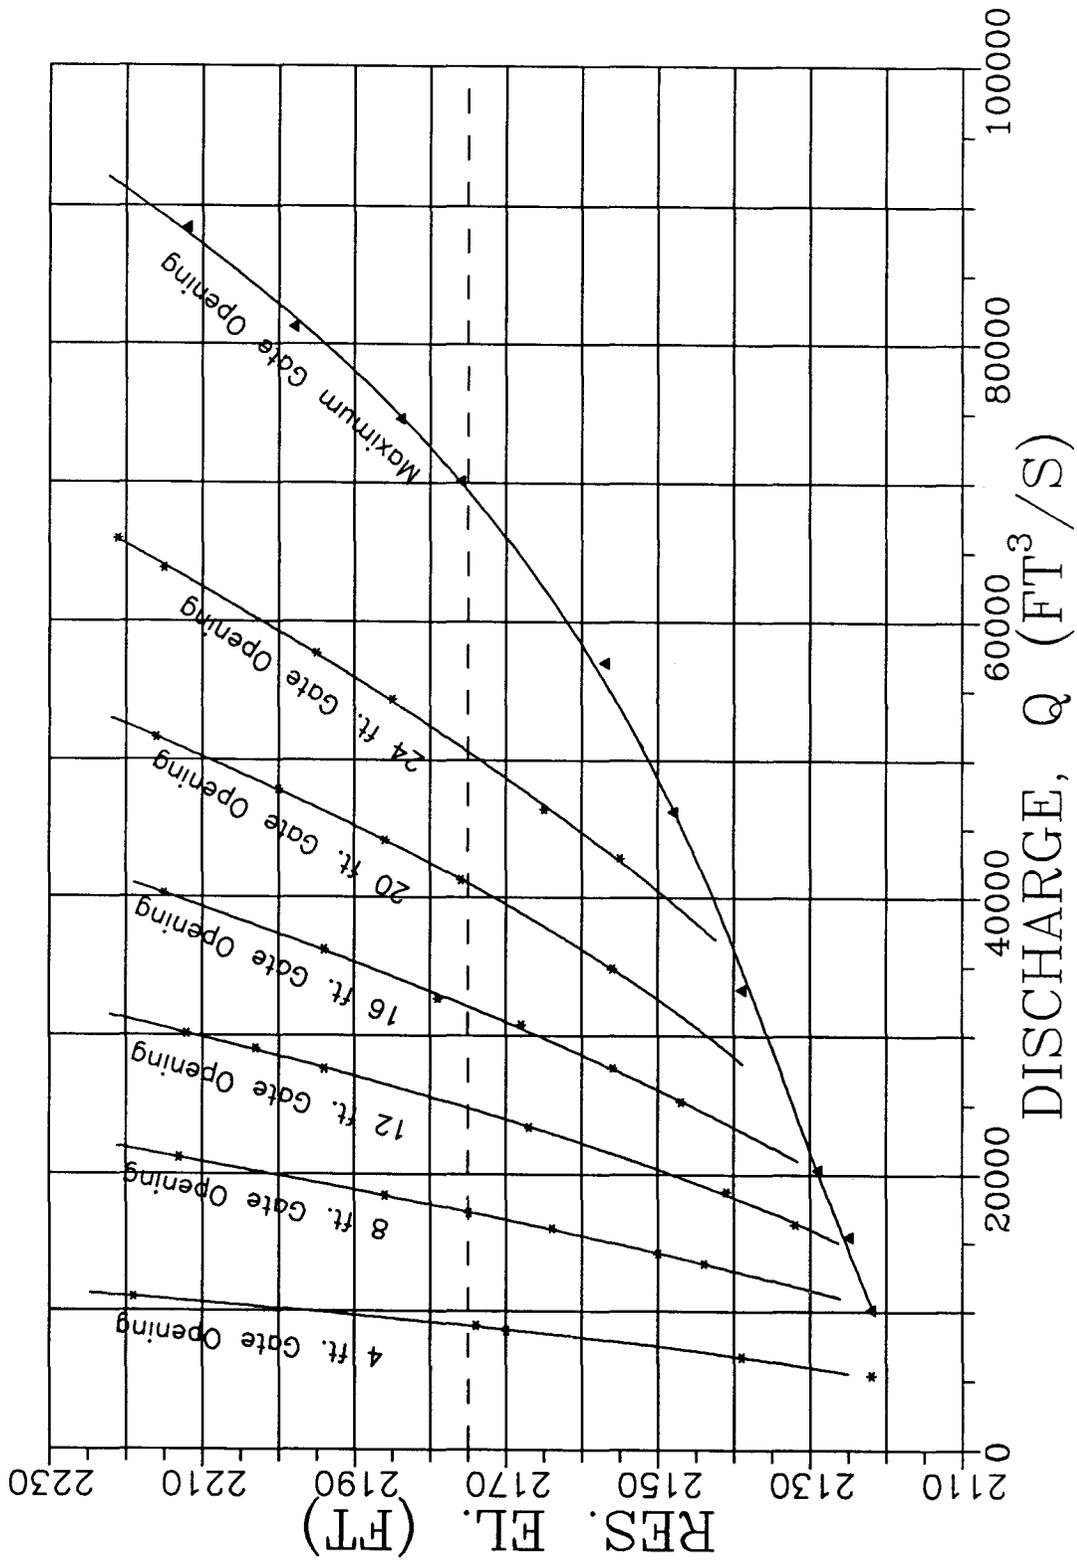
Figure 7. - Discharge rating curve for right abutment spillway operation.

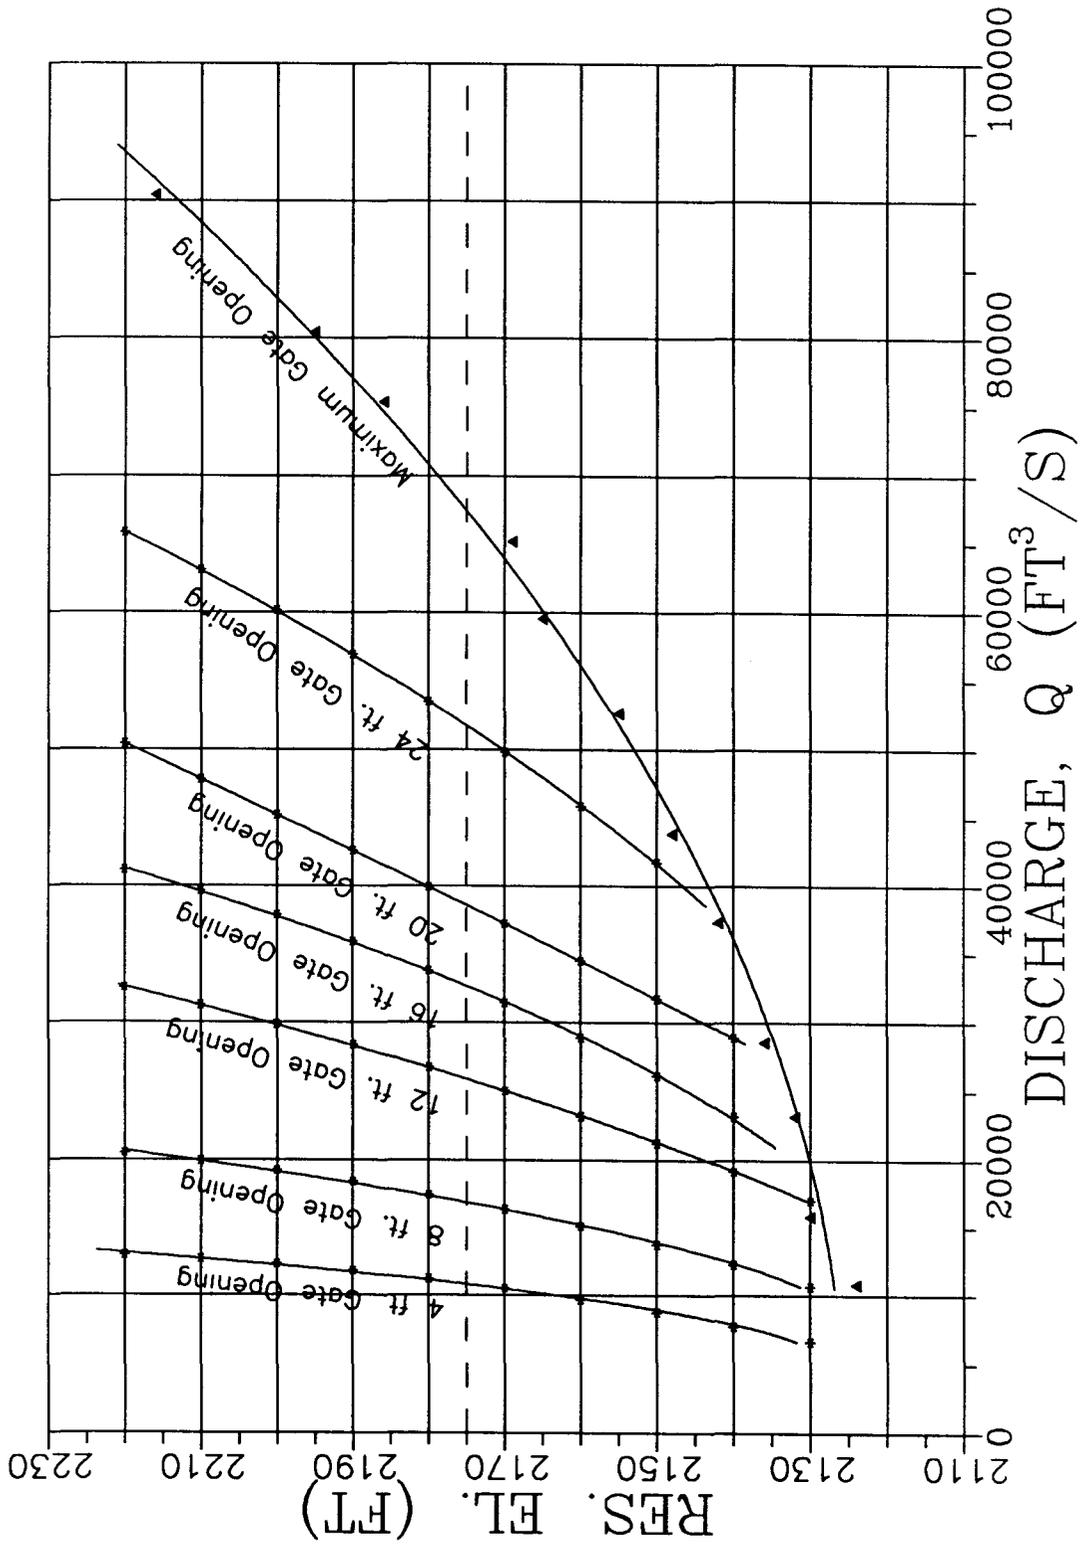
Figure 8. - Discharge rating curve for left abutment spillway operation.

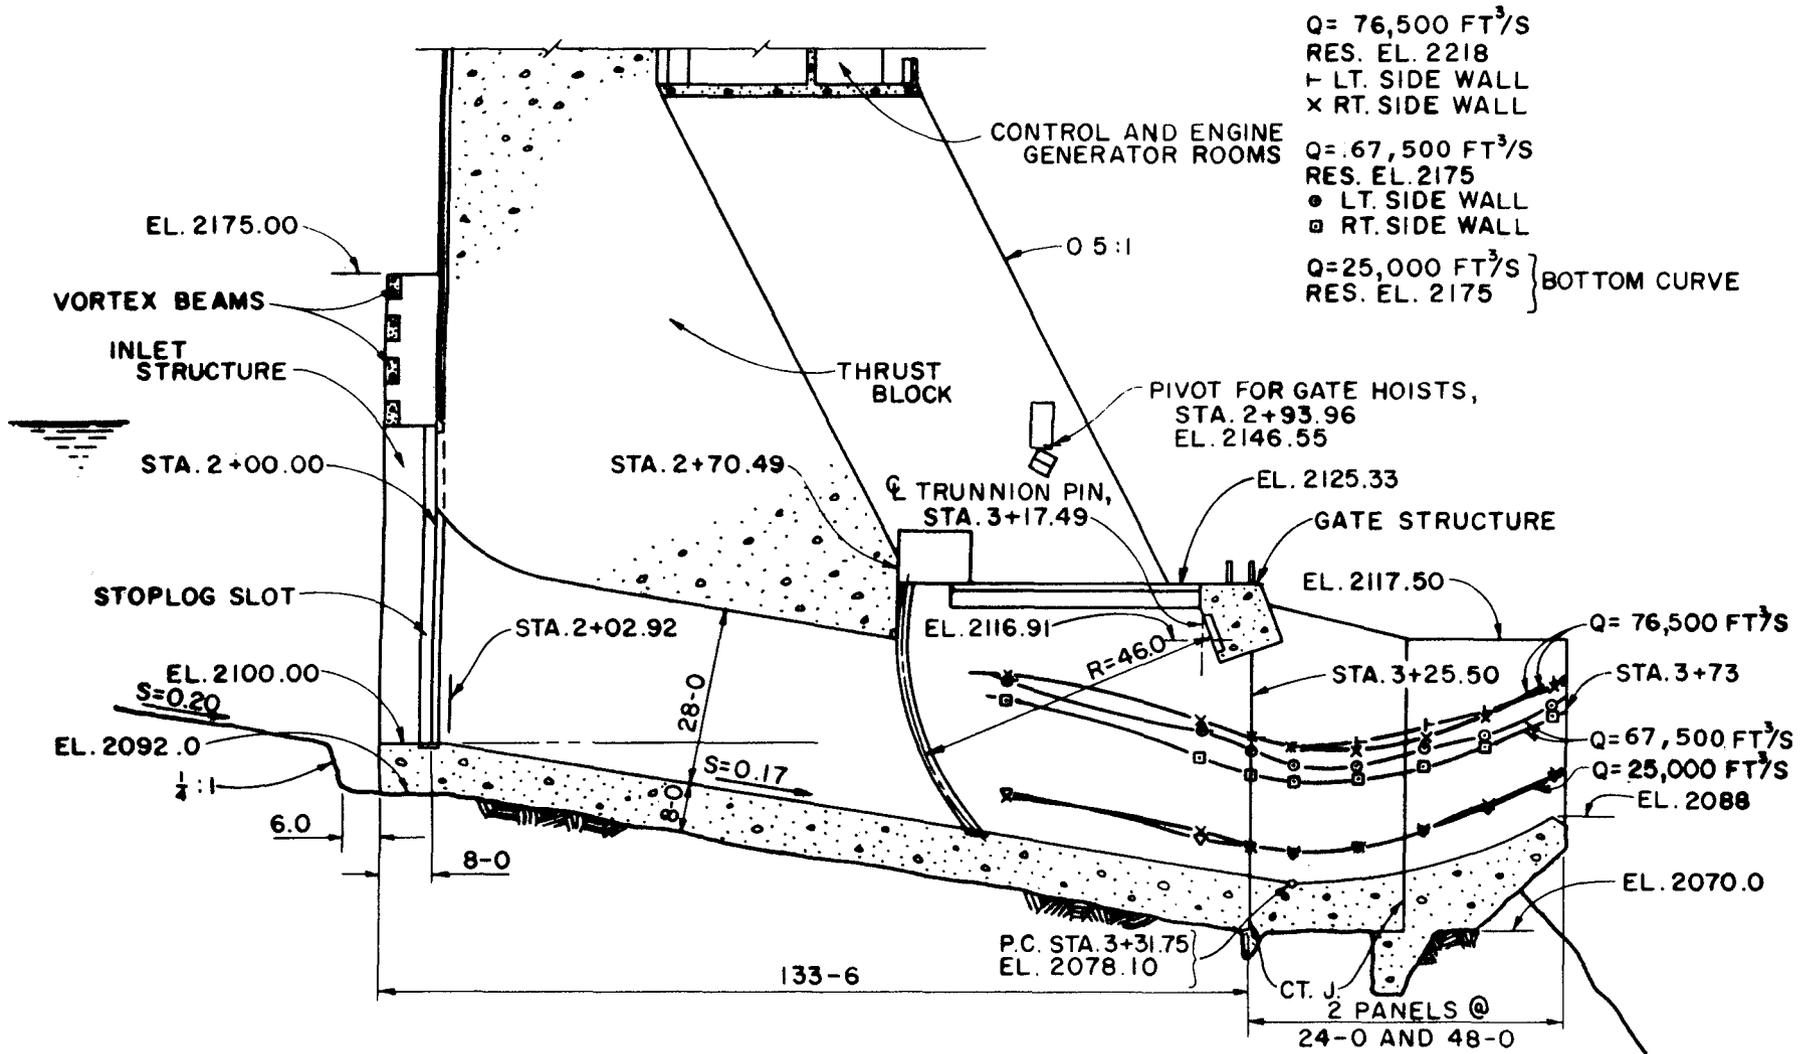
Figure 9. - Chute water surface profiles for the right spillway.

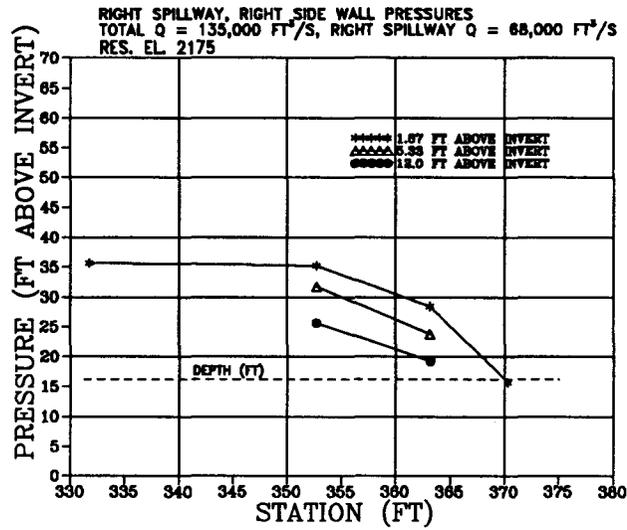
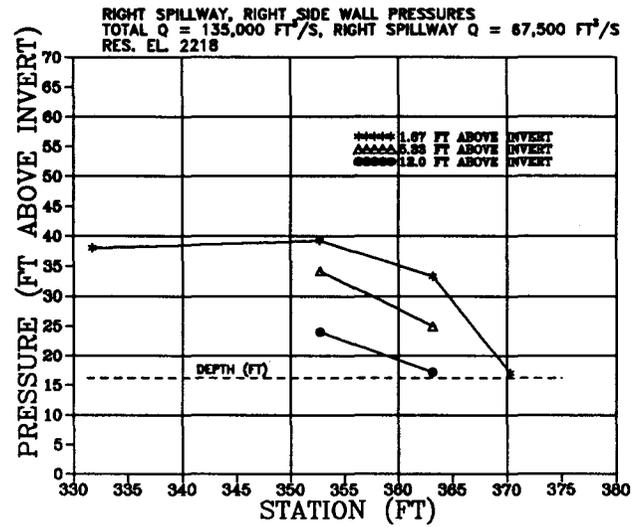
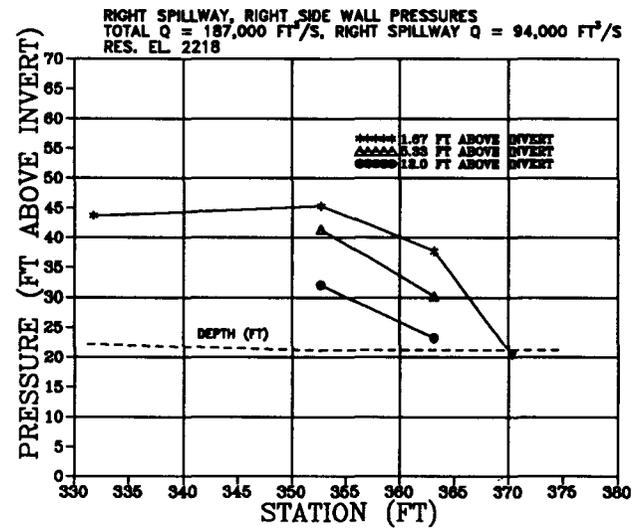
Figure 10. - Side wall pressures through the flip bucket for the right spillway.

The correct left spillway superelevation was essential for producing uniform flow depth across the chute and acceptable plunge pool energy dissipation. New water surface profiles were recorded throughout the spillway chutes that proved the adequacy of the left spillway superelevation and determined wall heights for both spillways (figs. 9 and 11). Side wall pressures through the flip bucket were also measured to confirm theoretical stability computations on the diverging walls of both spillways and the effect of the left spillway superelevation. Pressure data were recorded for 135,000 ft³/s at elevations 2175 and 2218, and 187,000 ft³/s at elevation 2218, which is the maximum possible discharge from the dam (figs. 10 and 12). The flare of both spillway chute side walls was acceptable.

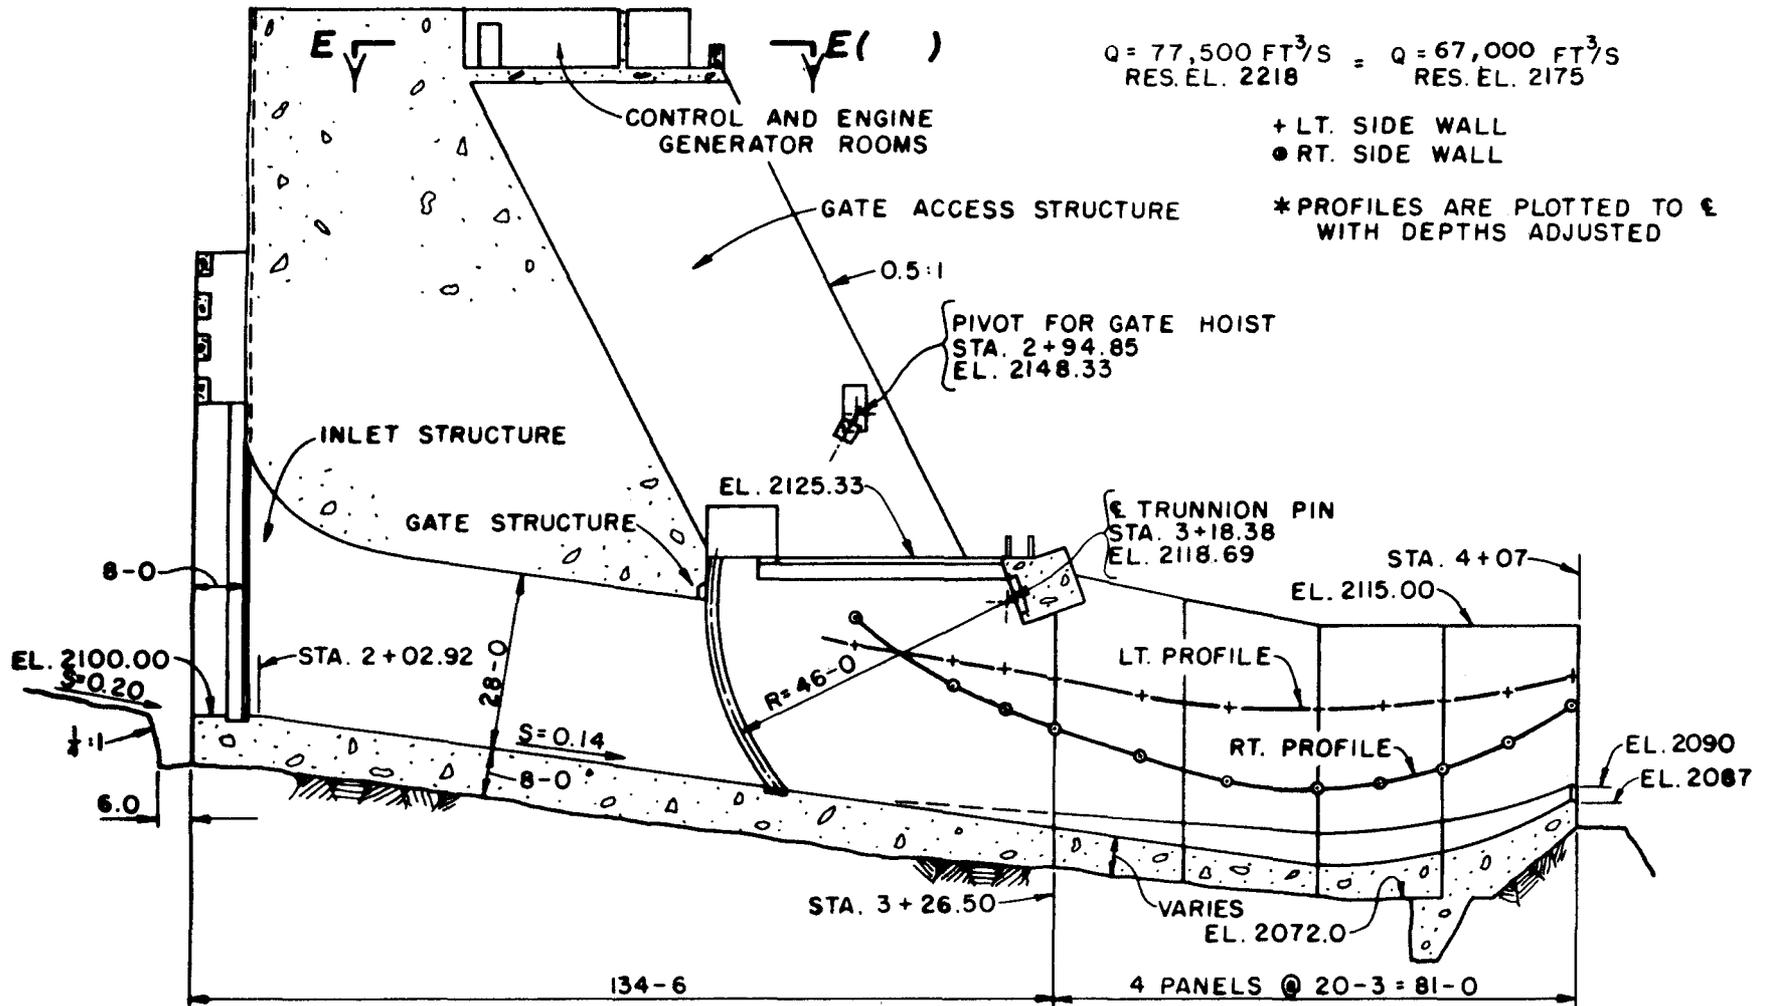
Figure 11. - Chute water surface profiles for the left spillway.

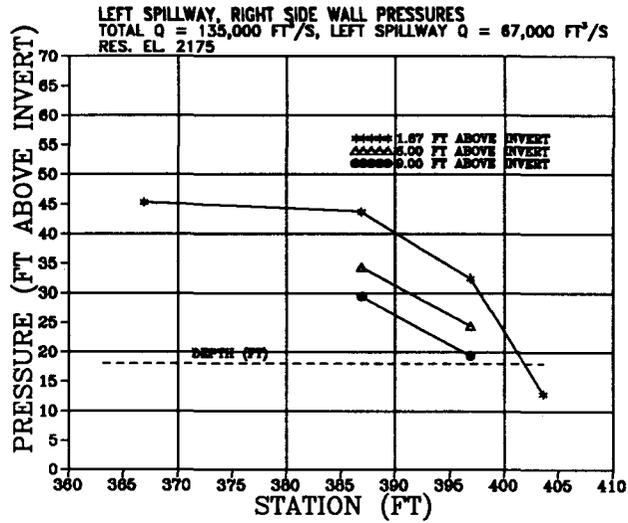
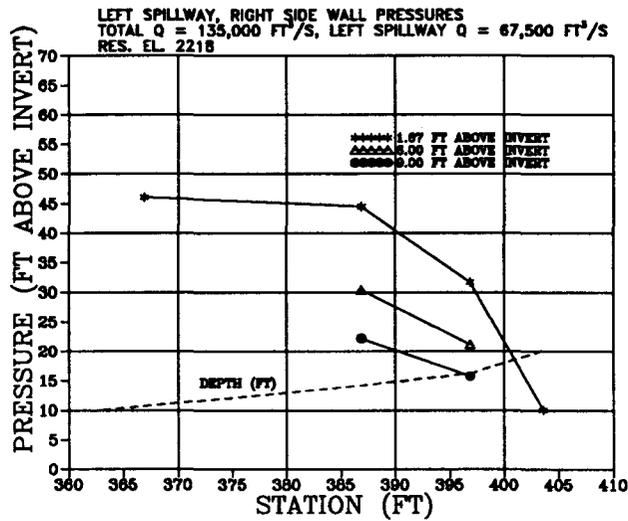
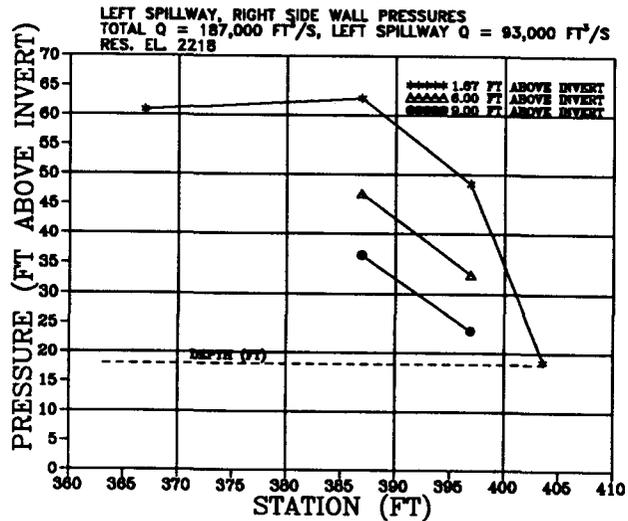
Figure 12. - Side wall pressures through the flip bucket for the left spillway.

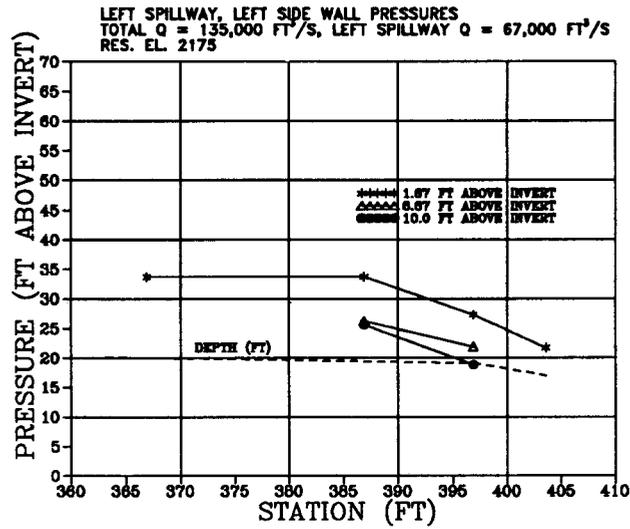
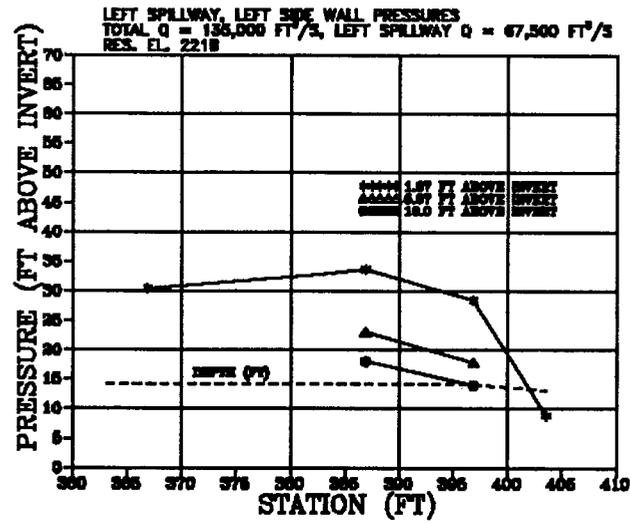
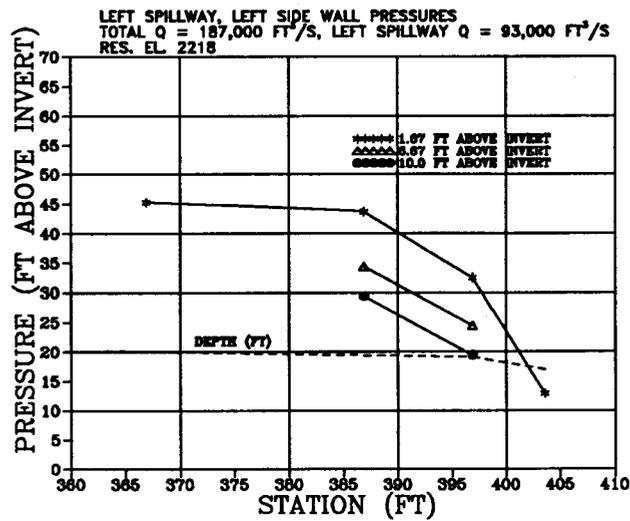
Figure 12. - Side wall pressures through the flip bucket for the left spillway. - Continued

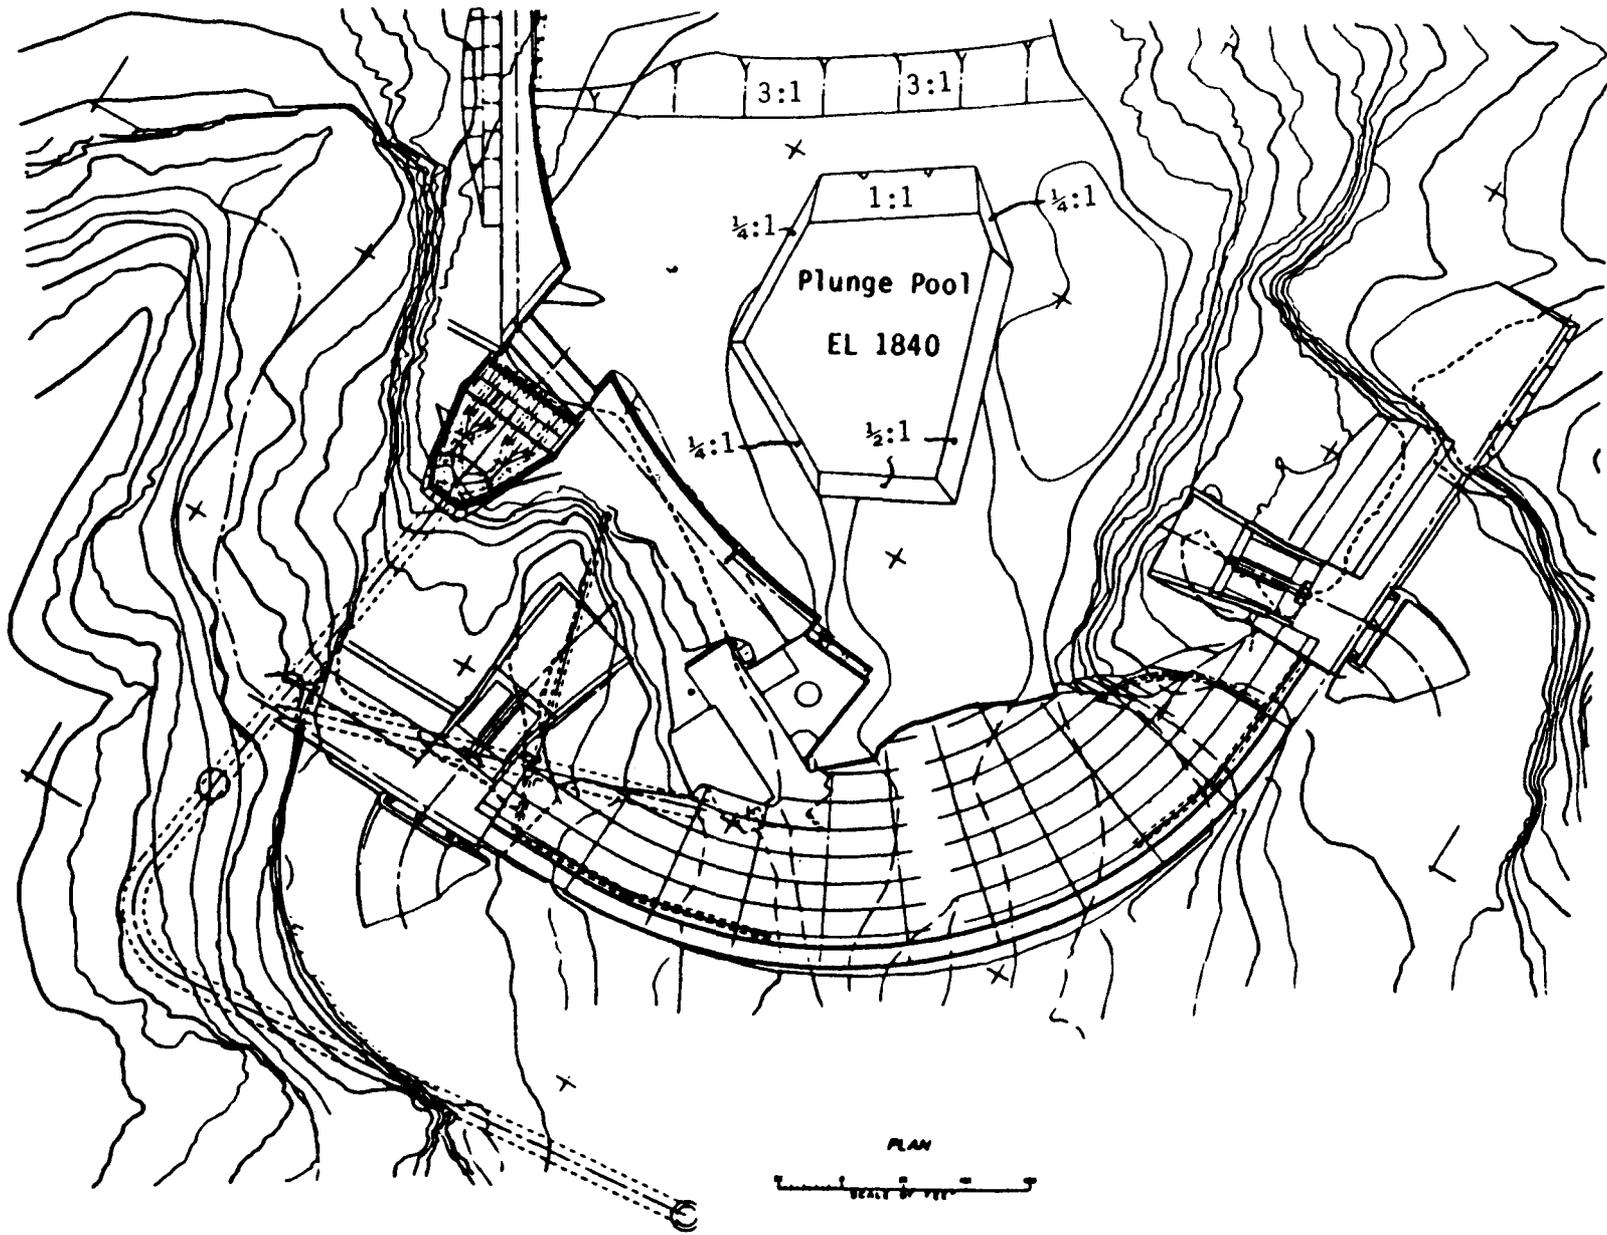
Figure 13. - General plan of the plunge pool and spillway designs for the single-curvature arch dam raise.

The final spillway and plunge pool configurations are shown on the general plan (fig. 13). All aspects of the waterways were retested except the pressure measurements in the plunge pool, which

The plunge pool geometry developed for the previous dam option was used for final design with the floor at elevation 1840 (fig. 13). The location of the pool was moved to the left and upstream to maintain the same jet impingement point relative to the pool with the final spillway alignment. Plunge pool energy dissipation remained similar with the exception that flows releasing from the downstream left side of the pool are closer to the road. Measurements of flow velocities between the pool and the road (fig. 16) did not show a significant increase compared to the previous design (fig. 39). The plunge pool adequately dissipated the energy of the design discharge. Flow at the toe of the dam remained calm. The final side wall slopes were modeled and did not have an appreciable effect on plunge pool flow conditions. The alluvial material was replaced in the river channel downstream and showed no significant difference in erosion or deposition patterns. The final spillway and plunge pool designs operating under the design discharge of 135,000 ft³/s at elevation 2175 are shown on figure 14.

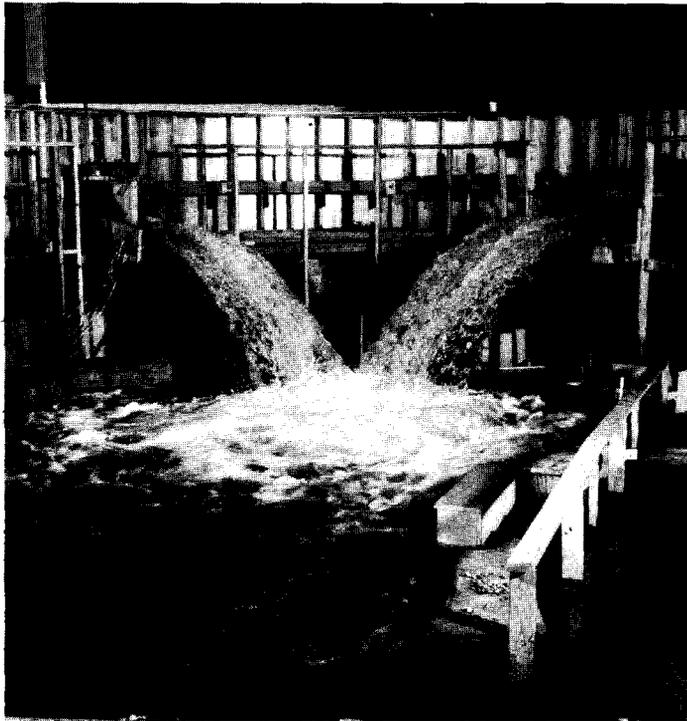
Figure 14. - Final plunge pool design dissipating the energy of the design discharge, 135,000 ft³/s at reservoir elevation 2175.

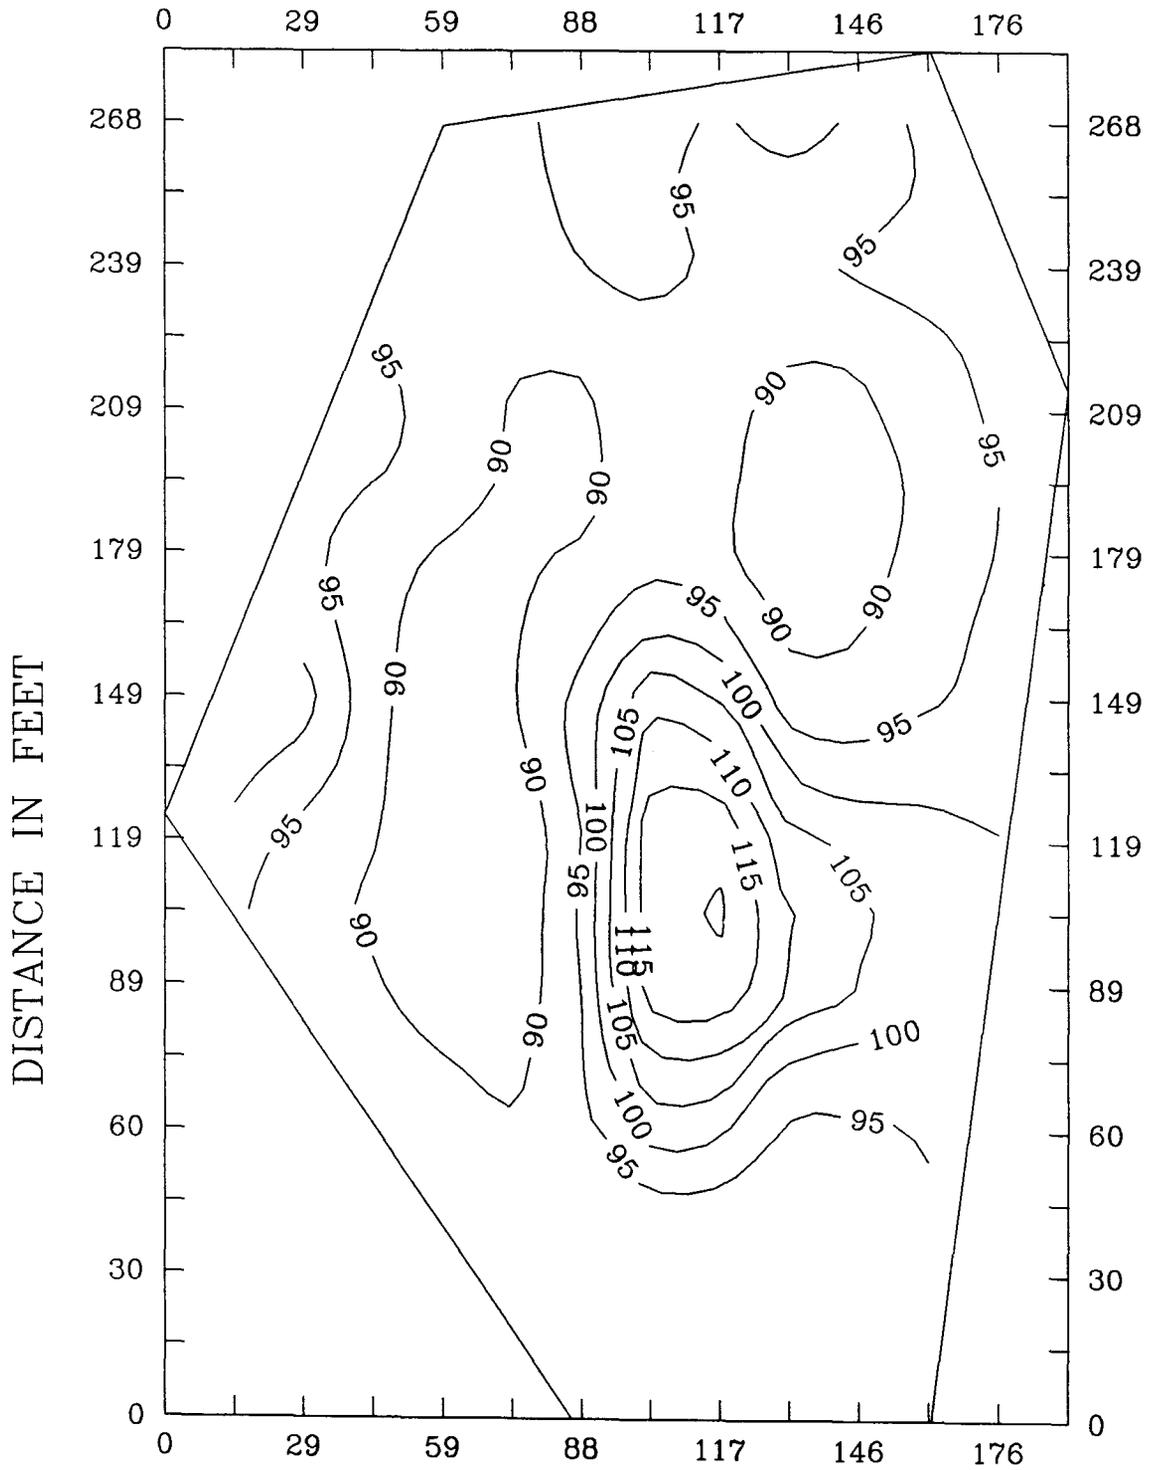
Figure 15. - Map of static pressures above the plunge pool floor at elevation 1840 for the design discharge, tailwater elevation = 1937 feet.
